ALTERNATIVE TREATMENTS OF OVER AND UNDERCROSSINGS FOR USE BY BICYCLISTS, PEDESTRIANS AND THE HANDICAPPED

January 1981
Final Report

1. Report No. FHWA-RD-79-70		2. Government Accession No.		3. Recipient's Catalog No.	
4. Title and Subtitle EFFECTIVE TREATMENTS OF OVER AND UNDERCROSSINGS FOR USE BY BICYCLISTS, PEDESTRIANS AND THE HANDICAPPED,				5. Report Date January 1981

6. Performing Organization Code	
7. Author(s) C. De Leuw, Jr., F. Danielson, W. Kudlick, S. Swan				8. Performing Organization Report No.	
9. Performing Organization Name and Address De Leuw, Cather & Company 120 Howard Street San Francisco, CA. 94105				10. Work Unit No. (TRAIS) FCP 31E3032

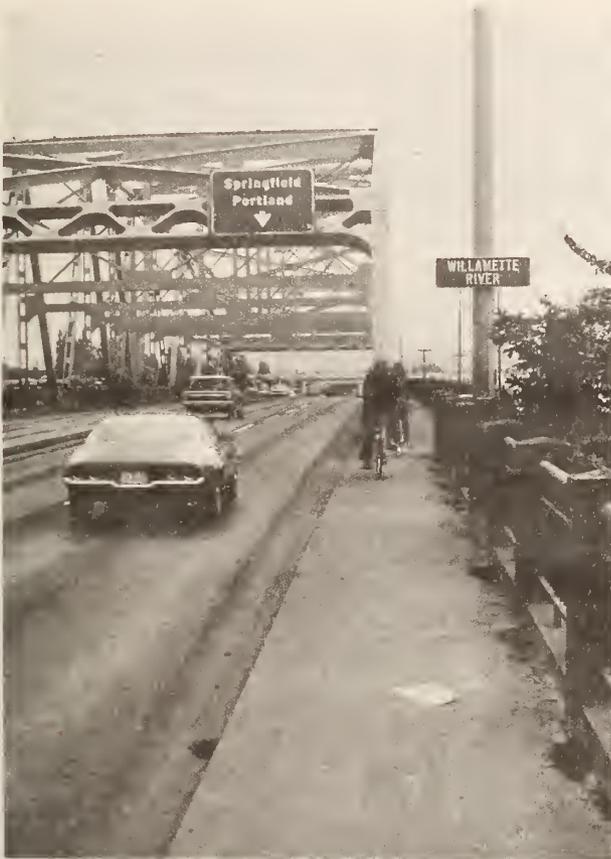
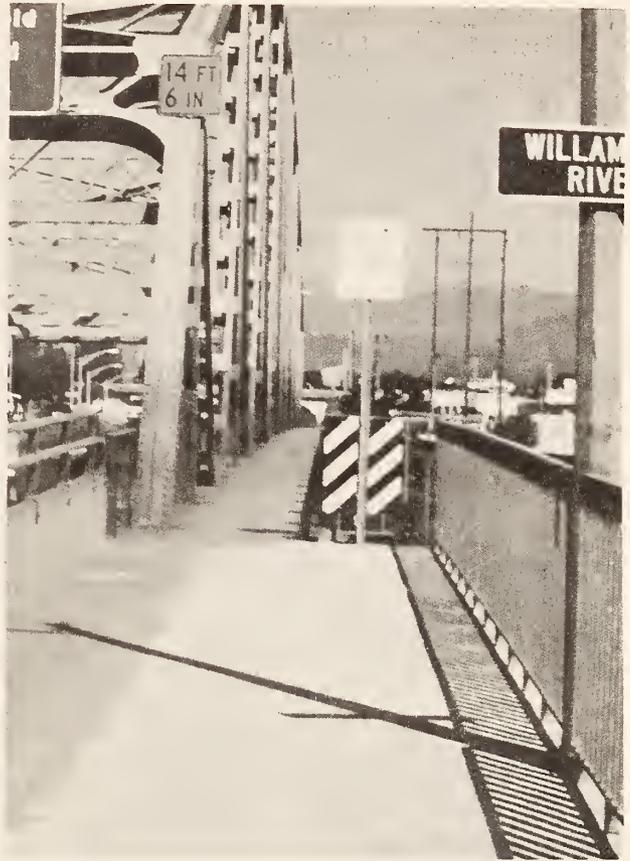
Narrow unprotected sidewalk
before improvement

Widened sidewalk with protected barrier
after improvement

The northeast sidewalk approach was widened by cantilevering an additional 5 foot (1.5M) section outside of the existing sidewalk. The cantilevered section is 250 feet (76.2M) in length, and provides a clear width of 10 feet (3.1M) between the new 4 foot (1.2M) high rectangular tubular steel outside pedestrian rail and the "New Jersey" type traffic barrier with handrail on the inside. The cantilevered section is supported by welded and bolted structural steel attached to the reinforced concrete beams and columns along the outside edge of the approach structure.

Approximately 500 L.F. (152.4M) of the "New Jersey" traffic barrier was erected, in addition to that adjacent to the cantilevered sidewalk section, on the other approach walks.

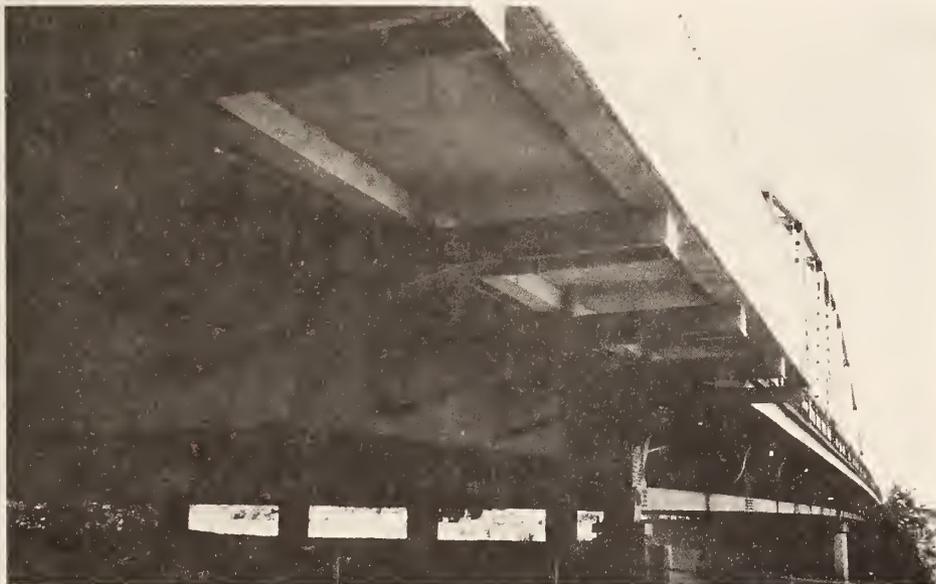
Cantilevered
supports for
widened sidewalk
after condition

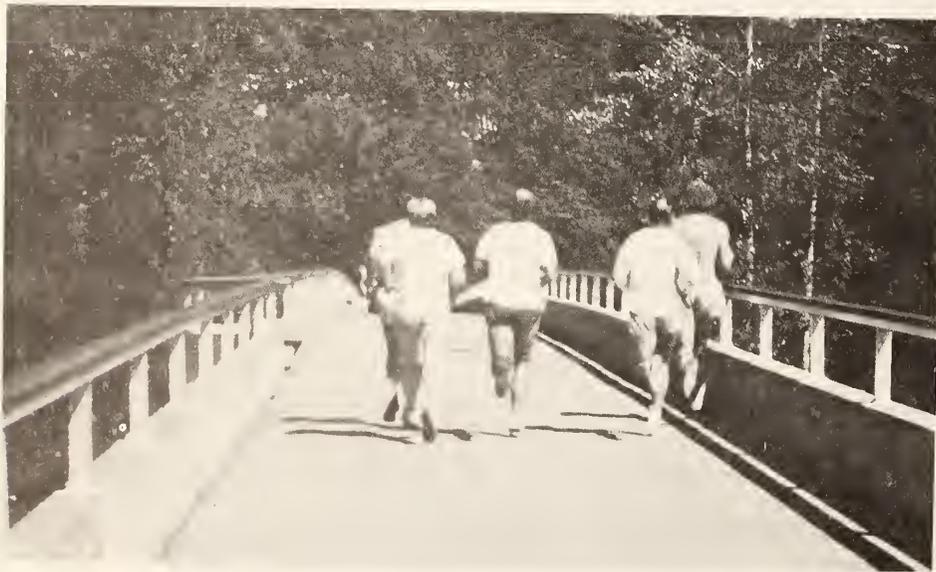
Figure 38. SUPPLEMENTAL INSPECTION SITES
Eugene, Oregon

Runners on the
Autzen bicycle
pedestrian
bridge over the
Willamette river

In addition to the case studies conducted at the Southern Pacific Railroad undercrossing and at the retrofitted ramp/Ferry Street Bridge complex, the study team also briefly inspected other elements of the north and south bank pathway system. The following information pertains to the Autzen Bridge and new Greenway Bike Bridge. See photographs, Figure 38.

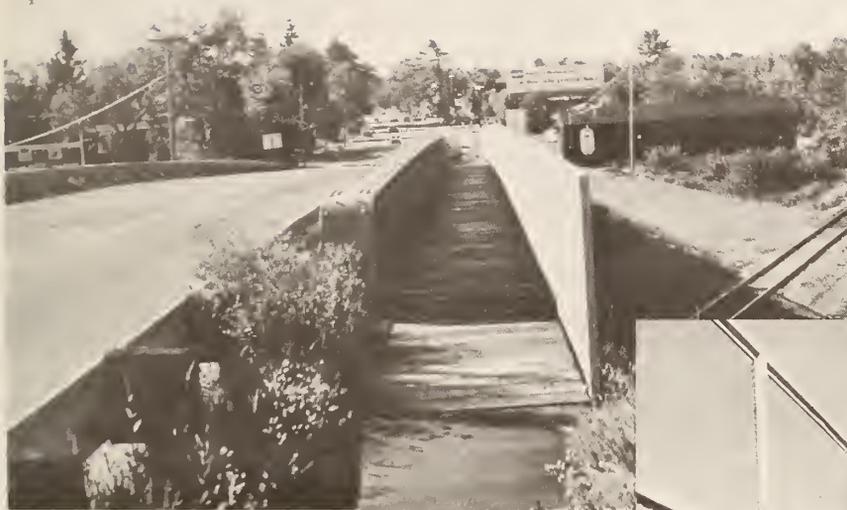
New walkway
cantilevered
onto existing
bridge

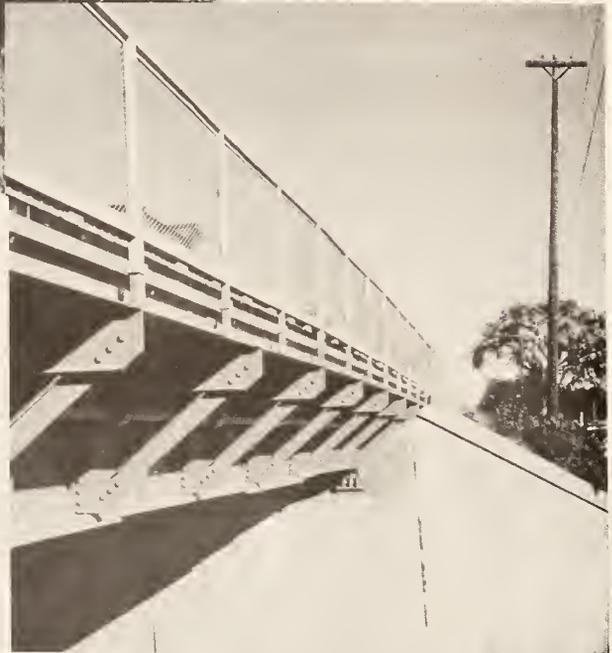
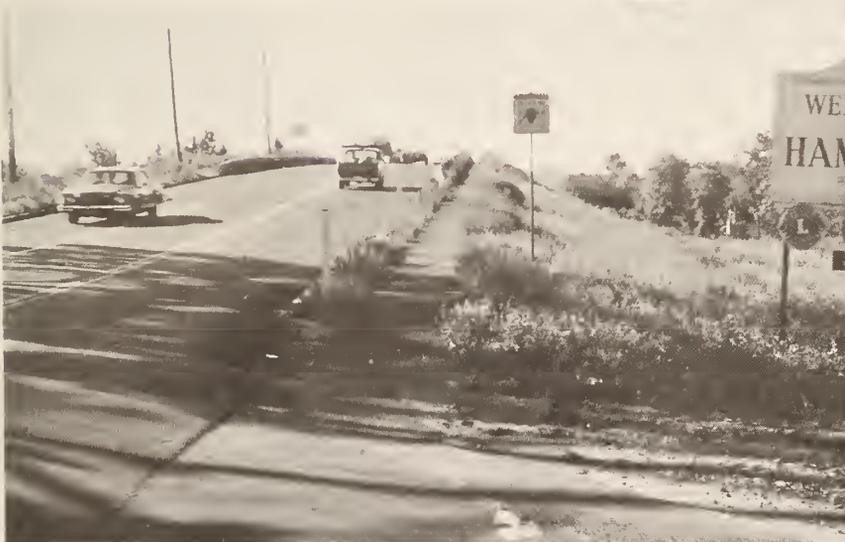
Figure 39. RETROFITTED BRIDGE
Hampton, New Hampshire

Cantilever detail

New pathway
built parallel
to roadway

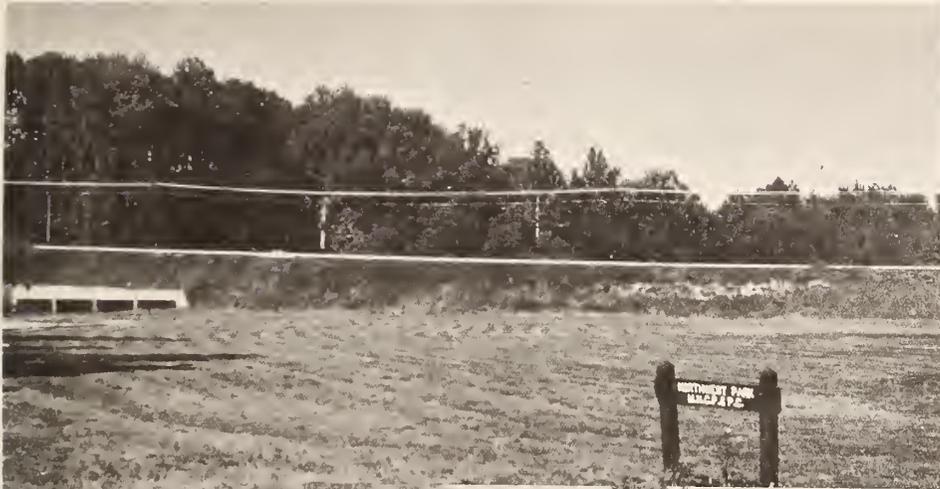
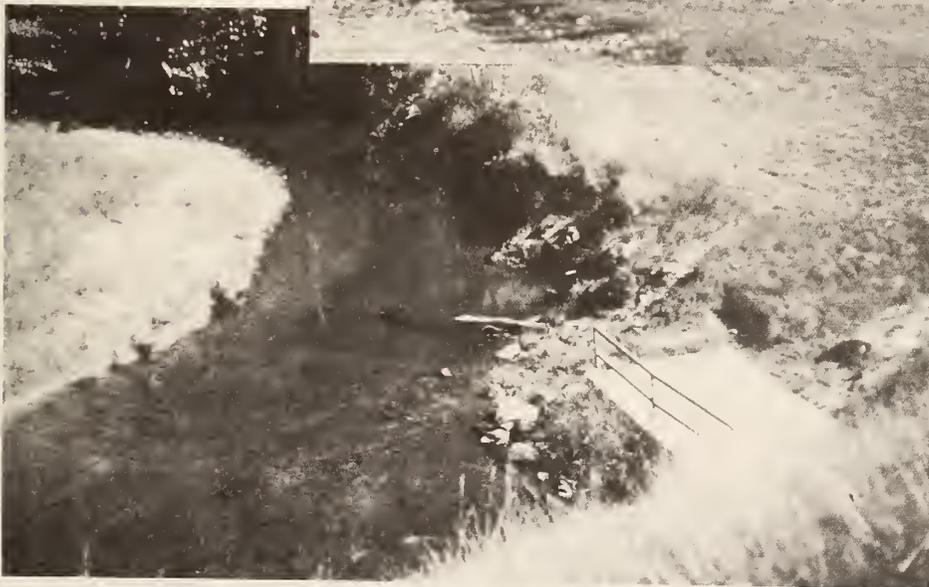
Figure 40. BOX CULVERT UNDERCROSSING
Maryland Route 183

Maryland
Route 183
crossing
over culvert

Pathway to be
extended in
the future

In the easterly cell, a concrete slab 8 feet (2.4M) wide was constructed next to the outer wall 3 feet 6 inches (1.1M) above the culvert invert. Overhead clearance of 7 feet 6 inches (2.3M) is thus available. A 3 foot (0.9M) high pedestrian handrailing constructed of pipe is provided at the outside edge of the slab. See photographs, Figure 40.

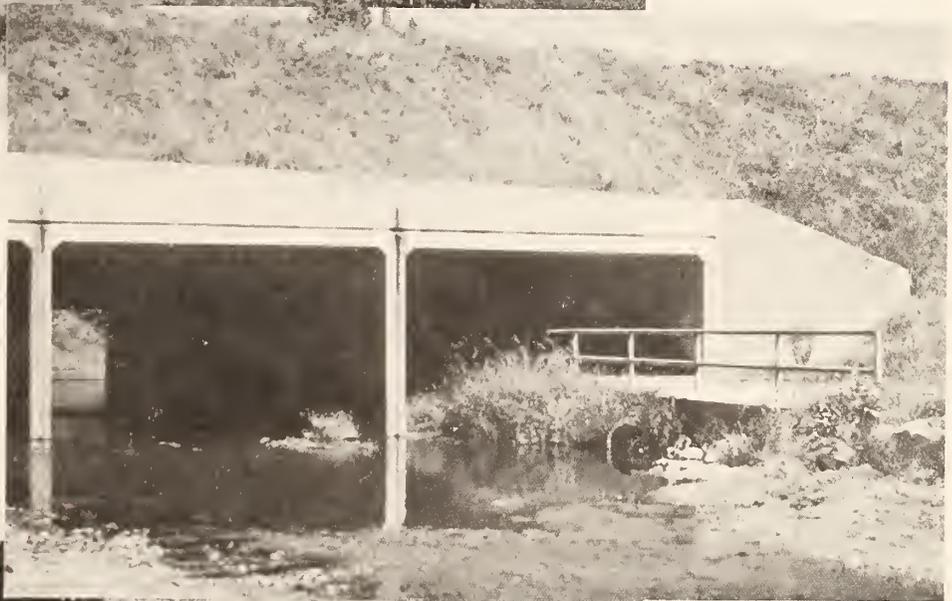
Raised walkway
shares culvert
cell

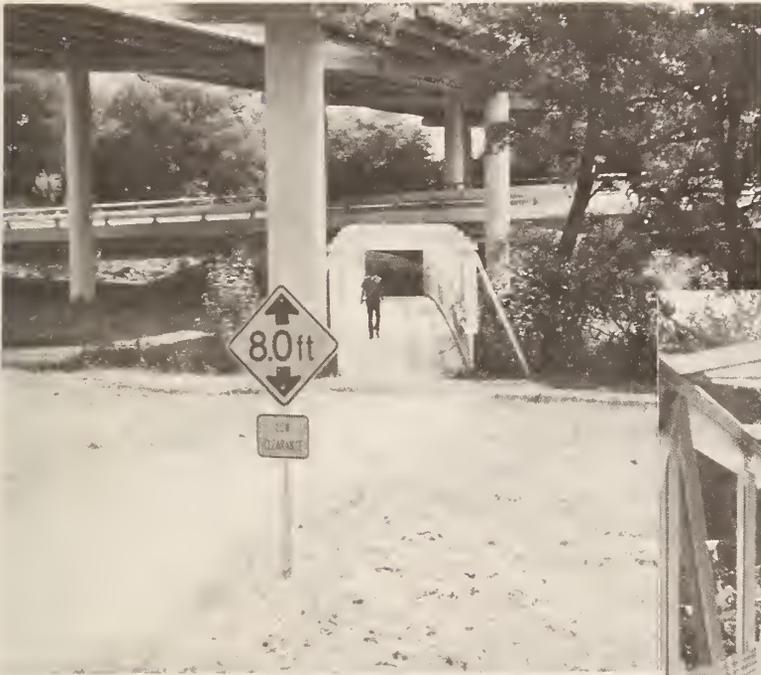
Figure 41. FIFTH STREET BIKEWAY
Austin, Texas

Signing and siting of bikeway bridge in interchange

The City of Austin received a Federal grant through the Bikeway Demonstration Program to mitigate the barriers to non-motorized travel created by the freeway interchange. The project was completed in 1977 and provides alternative pathways through the interchange by modifying existing structures, construction of pathways, and erection of two bicycle/pedestrian bridges. See photographs, Figures 41, 42 and 43.

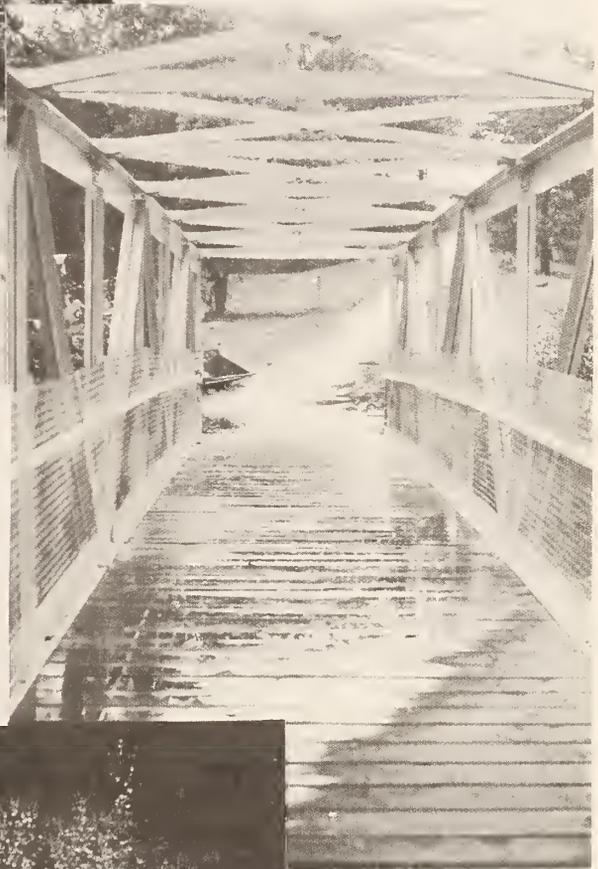
Bikeway bridge close-up

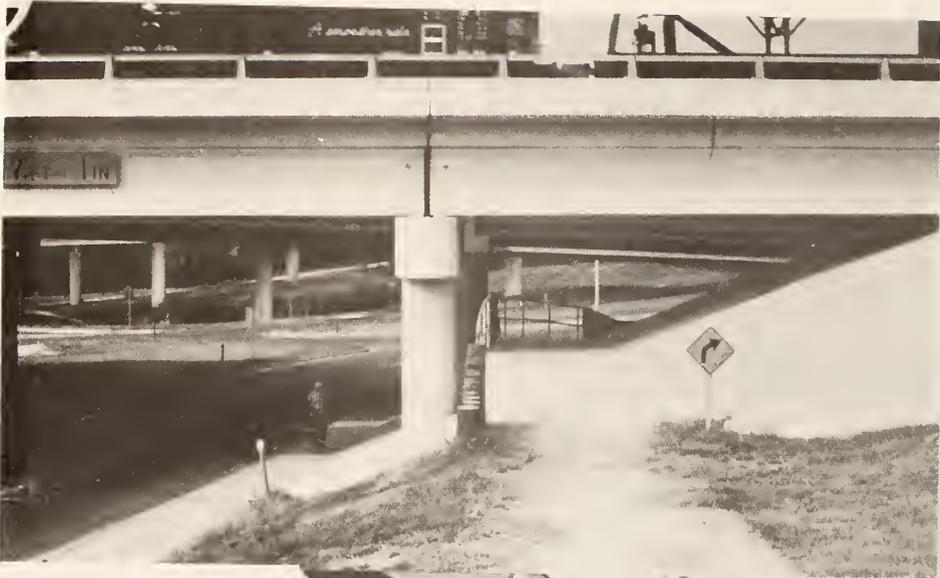
Figure 42. SIXTH STREET BIKEWAY
Austin, Texas

Original sidewalk and new bikeway crossing under railroad

Bikeway bridge positioned between freeway ramps

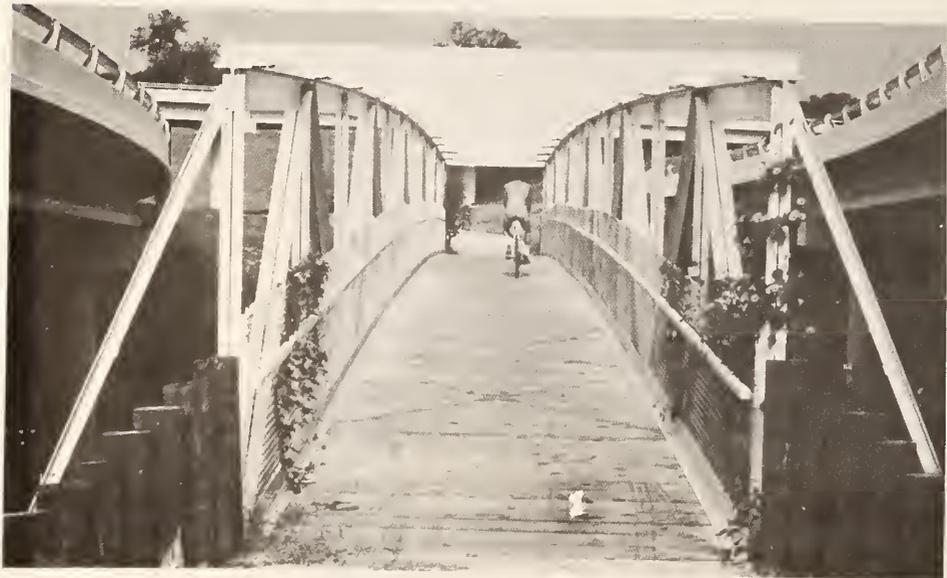
Bikeway bridge close-up. Note handrail, fencing and wood post wing walls

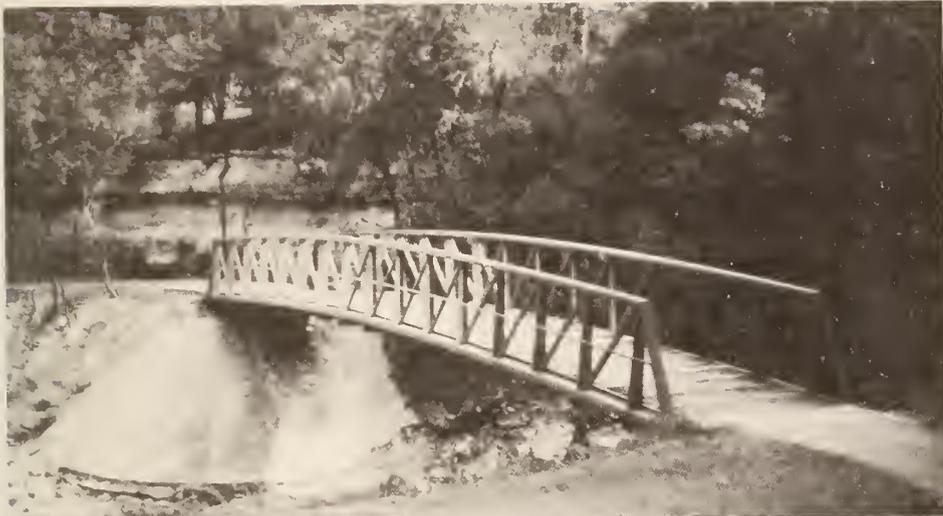
Bike/Pedestrian bridge connect pathway to culvert underpass

Pathway utilizes culvert cell with a raised floor to cross under interchange ramp

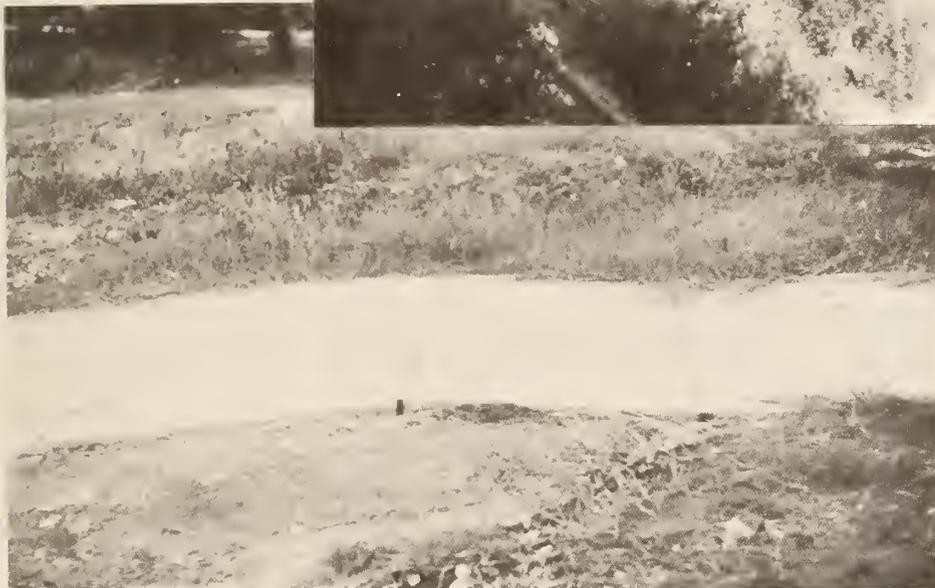
Figure 43. NORTH SOUTH BIKEWAY
Austin, Texas

One of several 3 foot (0.9m) long on-path level rest areas ascending a long hill
